Analysis of the Sludge From the Sludge pond and aeration  
pond (Lagoon) indicate the following levels of  
metal contaminants in October, 1980. The contaminants  
are compared to the National Interim Primary  
Drinking Water Regulations (1) OR the Water Quality  
Criteria Documents (2). ND = None Detected  
Federal Register

Owen-Corning Fiberglas  
Figures

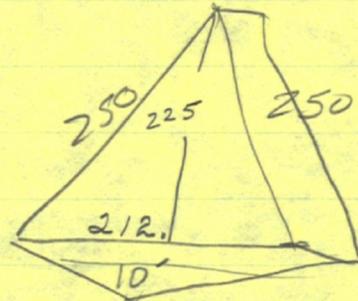
Figure 4. Calculation on amount of sludge in  
sludge holding pond

180 150 height  
23,872,500 cubic feet  $\div 200$  145 base

$\frac{1}{2} \cdot b \cdot h = 108750.$

4027 cubic yds  
90 1,800,000  $\div 27 =$

6,700 cubic yds
